An ad-hoc fire resistance test adopting the appropriate procedures and criteria of B.S. 476: Part 20: 1987 on a NuLite Ltd NL604(C) Fire Resistant Roof Light glazed with a Pilkington fire resistant insulating glass unit.

SUMMARY

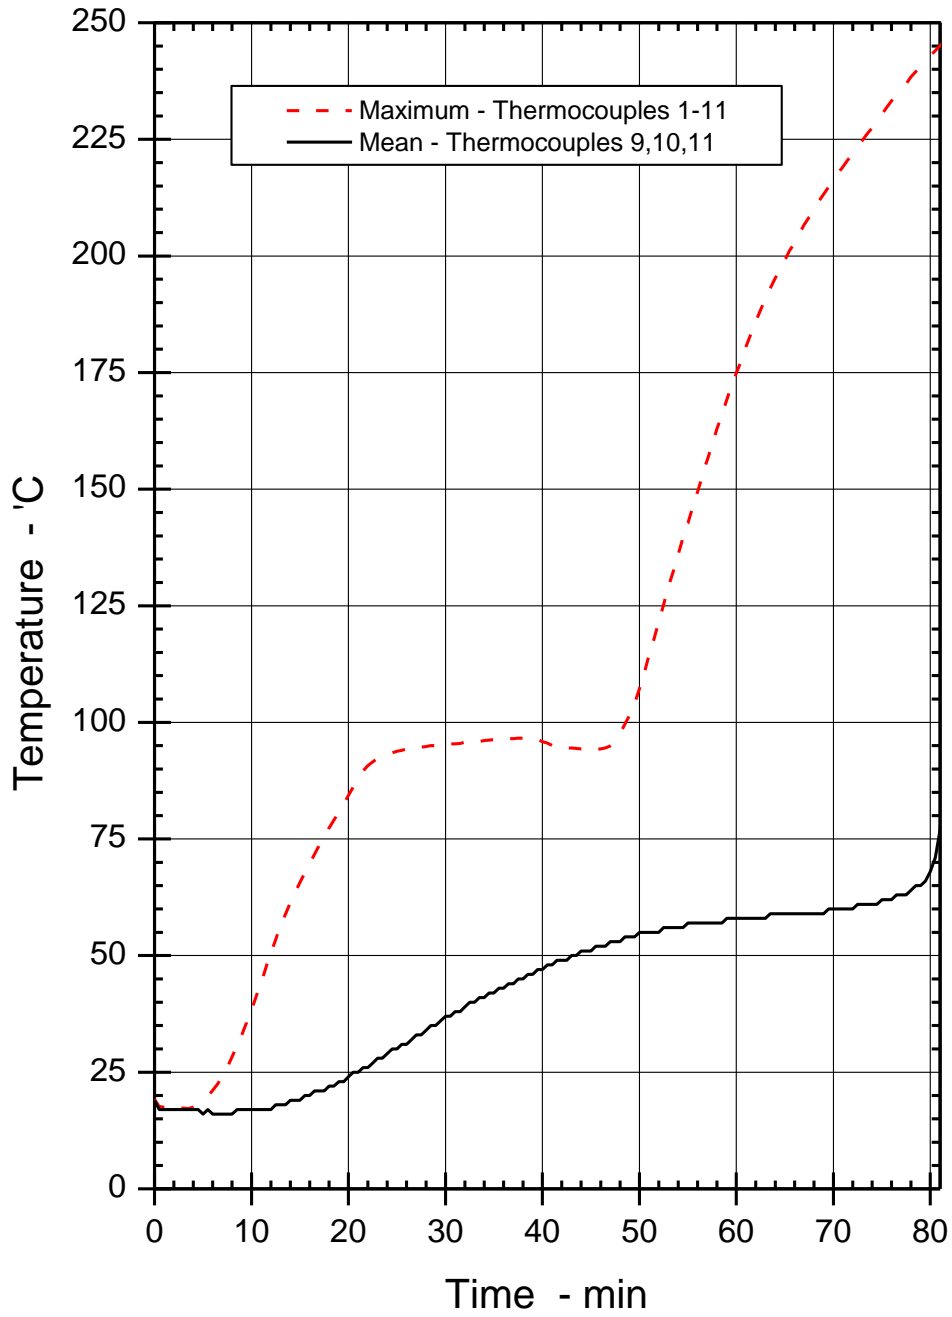
Graph 2 Maximum temperature recorded by all unexposed face thermocouples together with mean temperature recorded on glazing.

The adopted criterion for insulation (180° C rise) was first exceeded by thermocouple 2 after 64min from the start of the test.

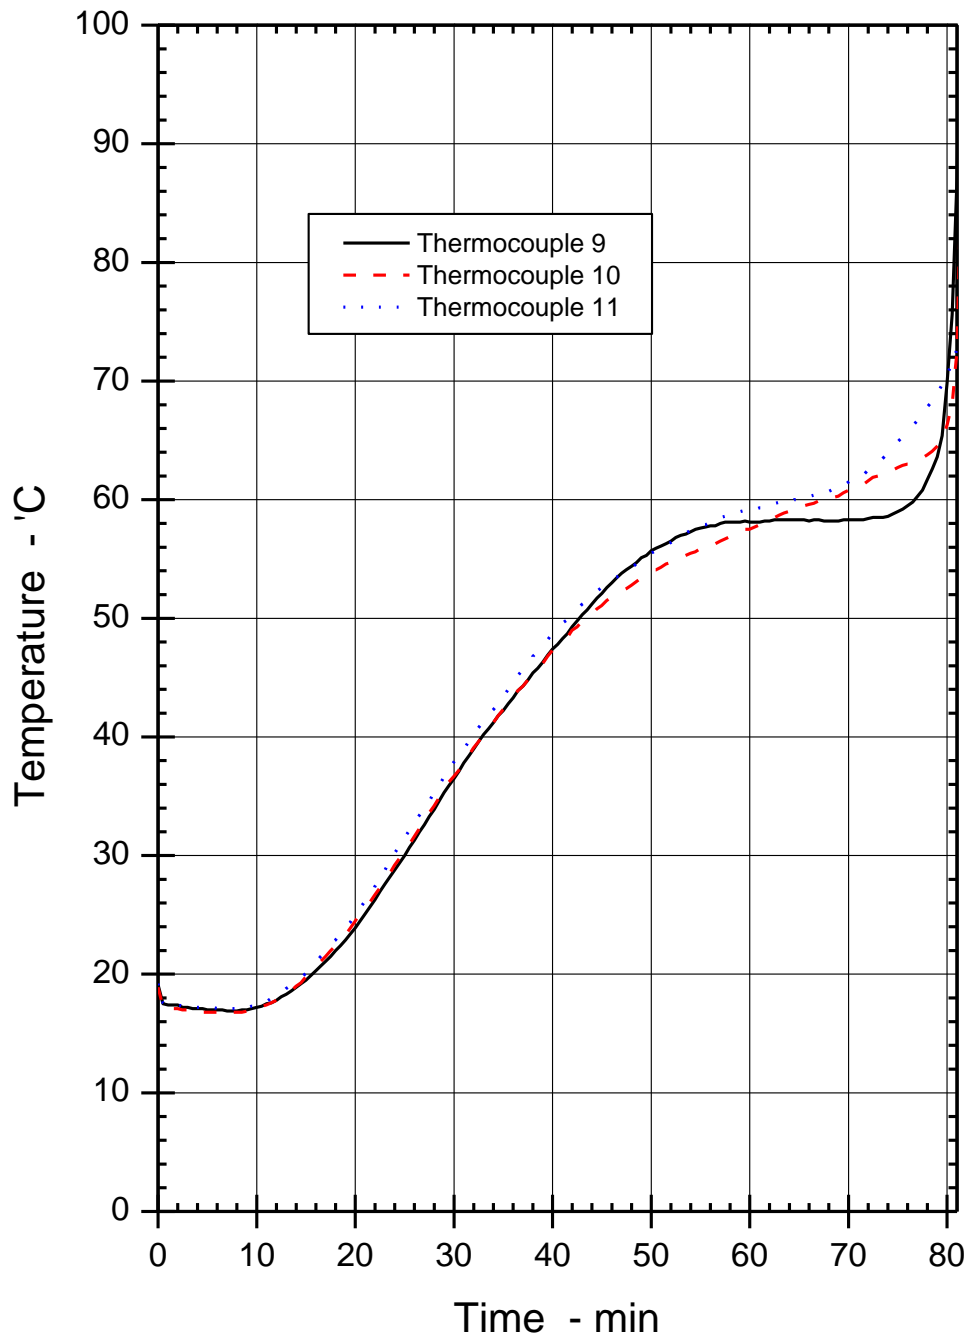
Graph 5 Temperature recorded by thermocouples 9 to 11 attached to glazing.

39:00	On unexposed face there is a uniform white appearance over whole of exposed area of glazing apart from a small slightly discoloured area, approximately 100mm in diameter, in vicinity of thermocouple 11 locations. Only a few cracks in inner glass layers visible around perimeter of glazing. No appreciable distortion of top of glazing or rooflight.

49:00	On unexposed face slightly discoloured area in vicinity of thermocouple 11 location has increased in size to approximately 200mm in diameter.
51:00	On exposed face no appreciable change apart from brighter glow.
